Release Note LS-300 VA1 v2.11.20.76

(This version is only compatible with the new HW version – VA1)

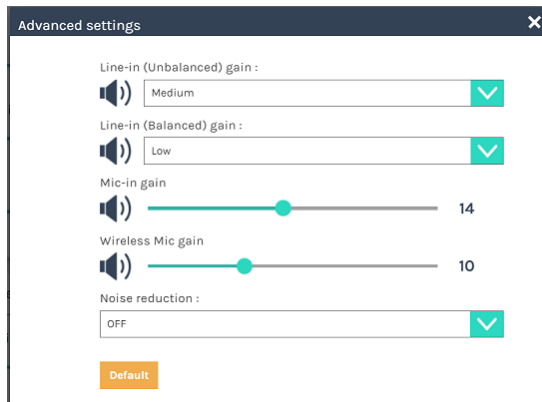
1. Differential audio input with phoenix type connector is “only” available on **LS-300**, **LS-400** and **KL-3T**.
2. Audio Noise Reduction (Line-in/Mic-in)
It can reduce the background noise that is present in recordings.
3. Audio Gain Control (Line-in/Mic-in)
Both balanced (Phoenix) and unbalanced (3.5mm) audio inputs have “Gain Control”.
 - Line-in (Unbalanced/Balanced): 3-step gain – Low, Medium, High
 - Mic-in/BT-Mic: 30-step gain

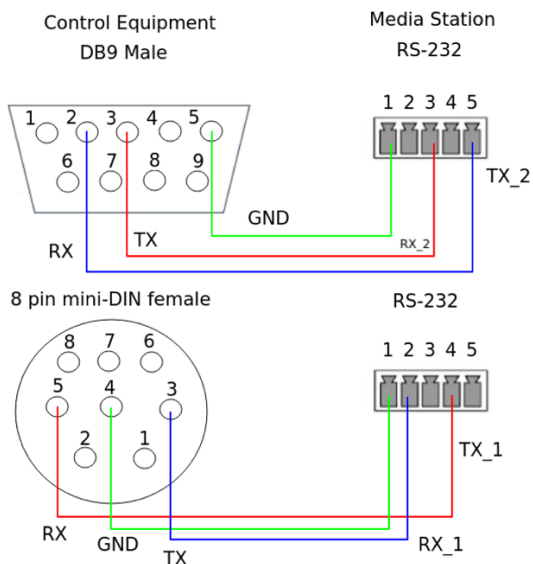
4. Equipped with one RE-232 camera control port
The same RS-232 port can now send commands for camera control while receiving commands from control systems.
* It can only control one camera, for additional cameras, USB-RS-232 cables will still be needed.
